Subject: Engine Flywheel Housing Requirements and Fault Code 250 – Endurant HD and PACCAR Transmission

Document Number: TAIB-0878

Date: May 17, 2021

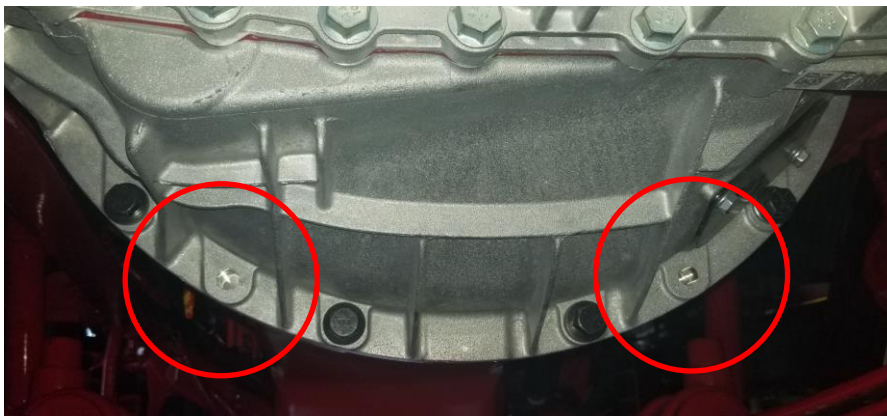
SAE J617 #1 flywheel housing minimum requirement (Transmission to Engine Flywheel Housing) is 12 fasteners. Endurant was launched with 16 fasteners (PACCAR Required 4 additional fasteners). Some customers (DTNA / VOLVO) may notice “Missing” fasteners. Cummins released an SAE Split difference flywheel housing (12 holes) while the Endurant clutch housing remained at 16 fastener hole capacity. The SAE for a #1 flywheel housing minimum requirement is 12 fasteners.

Not Required (Transmission housing has additional holes at 1, 5, 7, and 11 o'clock)

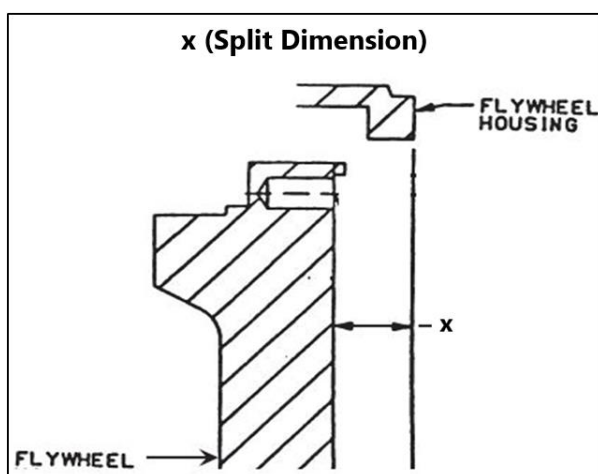
The Endurant Transmission requires a specific engine flywheel housing to ensure the correct Split Dimension. The Split Dimension is the distance from the engine flywheel machined surface to the engine flywheel housing where the transmission clutch housing attaches. See Cummins TSB190160

1. If the engine or engine flywheel housing requires replacement, contact the OEM and/or engine manufacturer to identify the engine flywheel housing part number based on the transmission model.
2. To verify the correct engine flywheel housing is installed, measure the Split Dimension, and reference the chart below. See Cummins TSB190160.
3. Fault Code 250 may also be set if the incorrect clutch release bearing is installed. Reference TRSM0950 for release bearing dimensions.
4. Fault Code 250 may also be set if a replacement transmission has the incorrect input shaft dimension. Reference TRSM0950 for input shaft dimensions and service transmission identification.

Endurant and PACCAR Transmissions				
OEM	Engine	x (Split Dimension)		Details
		mm	in	
Navistar	A26	65.70-67.59	2.59-2.66	66.645mm (+/-0.9445)
Navistar	X15	65.70-67.59	2.59-2.66	
PACCAR*	MX13/15	65.70-67.59	2.59-2.66	
PACCAR	X15	65.70-67.59	2.59-2.66	
Volvo	X15	59.8	2.35	
DTNA	X15	59.8	2.35	
DTNA	DD13/15	56.63-59.17	2.23-2.33	57.9mm (+/-1.27)
UltraShift PLUS/Fuller Advantage Automated				
All	All	63.50	2.50
